**Flood Control Project Maintenance
Levee Inspections**

Maintenance Issue Types Only, Levee Inspection Report By Mile - Fall 2018

Reclamation District No. 2062 Stewart

Waterway	Bank	Unit Miles	Inspection Start/End	Inspector
Unit No. 01 San Joaquin River	Left	2.64	10/29/2018 10/29/2018	Richard Willoughby

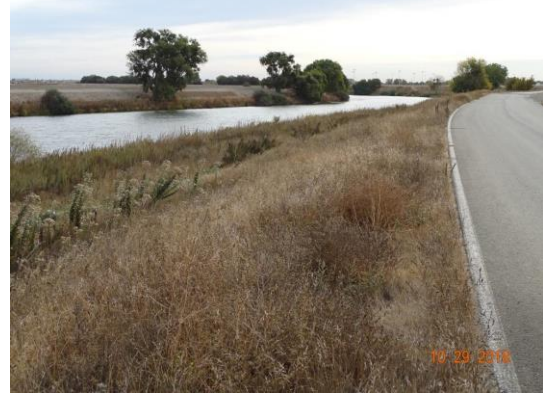
Photo 1 of 1 : FA_2018_RD2062_309_6_20181101_00010.jpg

LM Start	0.00	Rating **	M	Issue No.	6
LM End	2.63	Issue Type +	Ma	Location *	N/A
Category	Earthen Levee			GPS Latitude/Longitude	
				Start	End
Item	Vegetation			37.807505 °	37.787249 °
				-121.328103 °	-121.308947 °
DWR ID	DWR_RD2062_01_f _ 2018_6				
Comment Code					
V1 : Control annual grass and weeds on the levee slopes and easements.					
Inspector Comment

Typical view of levee slopes.

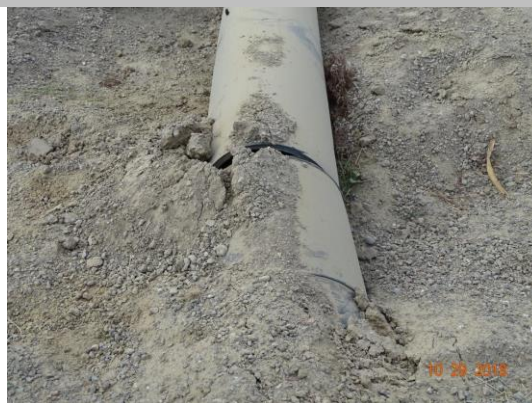
Photo 1 of 5 : FA_2018_RD2062_310_14_20181101_00035.jpg

Looking at broken pipe on waterward slope. (Fall 2018)

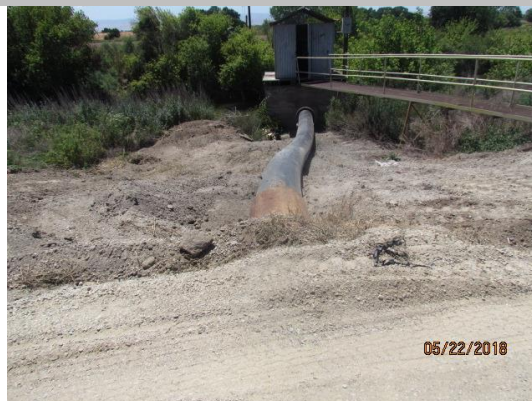
Photo 2 of 5 : FA_2018_RD2062_310_14_20180906_00003.jpg

Looking east at pumphouse and pipe on waterward slope. (Spring 2018)

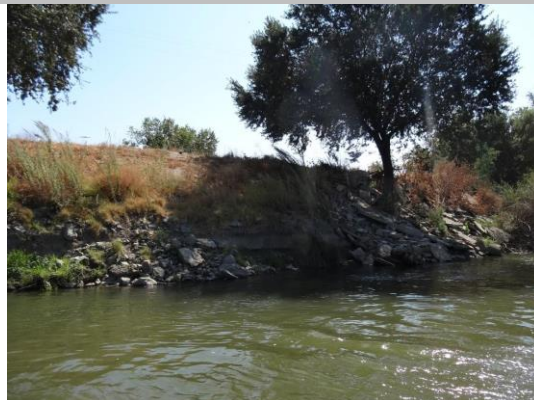
Photo 1 of 4 : FA_2018_RD2062_311_1_20180906_00001.jpg

LM Start	-0.03	Rating **	M	Issue No.	1
LM End	0.07	Issue Type +	Ma	Location *	WS
Category	Supplemental			GPS Latitude/Longitude	
				Start	End
Item	DWR Erosion Survey			37.809514 °	37.809514 °
				-121.390125 °	-121.390125 °
DWR ID	RD2062U03RM29.94				
Comment Code					
Inspector Comment					
09/13/2017: The erosion site has expanded significantly along the river bank.					
11/09/2016: No significant change observed.					
06/25/2015: The erosion is below a large oak tree. Vegetation is visible around the erosion site. [2017 Site ID:RD2062U03RM29.94]

Front view of the erosion site. Note the large tree above the erosion.

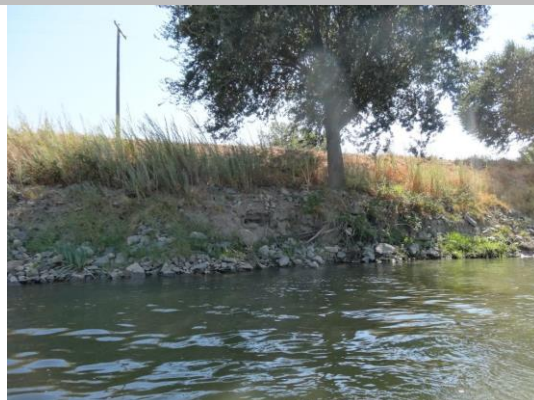
Photo 2 of 4 : FA_2018_RD2062_311_1_20180906_00002.jpg

Close view of the erosion.

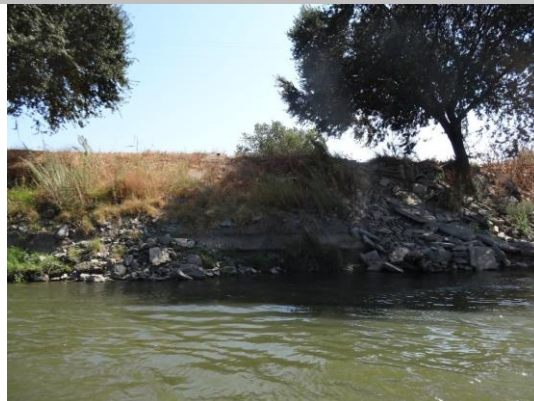
Photo 3 of 4 : FA_2018_RD2062_311_1_20180906_00003.jpg

Close view of the erosion.

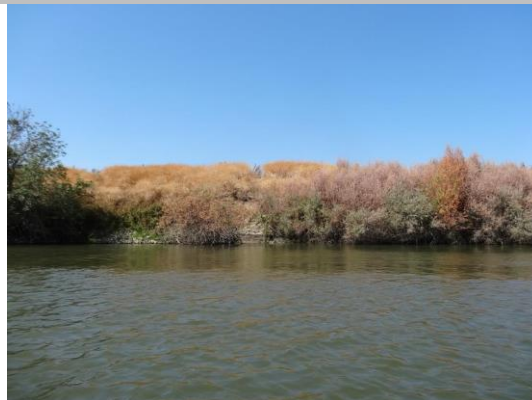
Photo 4 of 4 : FA_2018_RD2062_311_1_20180906_00004.jpg

LM Start	-0.03	Rating **	M	Issue No.	1 (cont)	
LM End	0.07	Issue Type +	Ma	Location *	WS	
Category	Supplemental			GPS Latitude/Longitude		
				Start		End
Item	DWR Erosion Survey			37.809514 °		37.809514 °
				-121.390125 °		-121.390125 °
DWR ID	RD2062U03RM29.94					
Comment Code						
Inspector Comment						
09/13/2017: The erosion site has expanded significantly along the river bank.						
11/09/2016: No significant change observed.						
06/25/2015: The erosion is below a large oak tree. Vegetation is visible around the erosion site. [2017 Site ID:RD2062U03RM29.94]

Close view of the erosion.

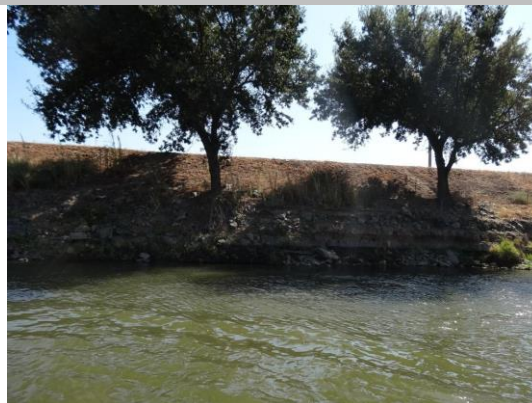
Photo 1 of 4 : FA_2018_RD2062_311_2_20180906_00005.jpg

Comment Code					
Inspector Comment					
09/13/2017: The erosion site has expanded significantly with the erosion length increased to approximately 90 ft from 40 ft. Signs of animal activities have been found at the site.					
07/25/2016: No significant change observed.					
06/25/2015: No significant change observed.					
07/02/2014: No significant change observed.					
08/13/2013: No significant change observed.					
08/07/2012: The site has been visited by boat survey. No significant change observed					
08/23/2011: Hard to view the erosion because of the dense vegetation and trees on site. The site is under the bush, close to the tree. [2017 Site ID:RD2062U03RM30.02]

Front view of the site.

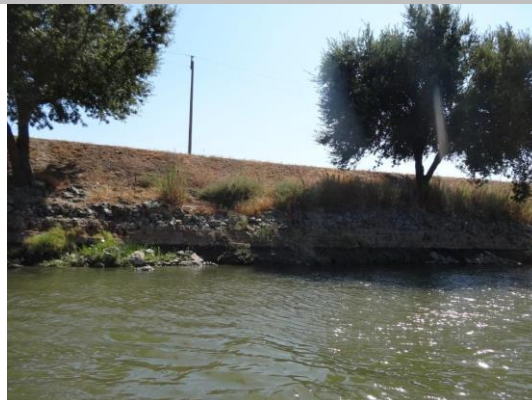
Photo 2 of 4 : FA_2018_RD2062_311_2_20180906_00006.jpg

Comment Code						
Inspector Comment						
09/13/2017: The erosion site has expanded significantly with the erosion length increased to approximately 90 ft from 40 ft. Signs of animal activities have been found at the site.						
07/25/2016: No significant change observed.						
06/25/2015: No significant change observed.						
07/02/2014: No significant change observed.						
08/13/2013: No significant change observed.						
08/07/2012: The site has been visited by boat survey. No significant change observed						
08/23/2011: Hard to view the erosion because of the dense vegetation and trees on site. The site is under the bush, close to the tree. [2017 Site ID:RD2062U03RM30.02]

Close view of the erosion. Note signs of animal activities at the site..

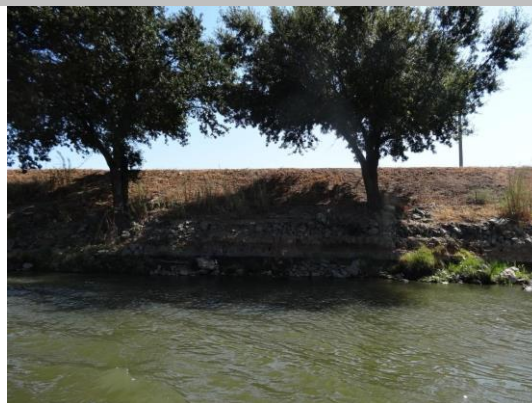
Photo 3 of 4 : FA_2018_RD2062_311_2_20180906_00007.jpg

Close view of the erosion.

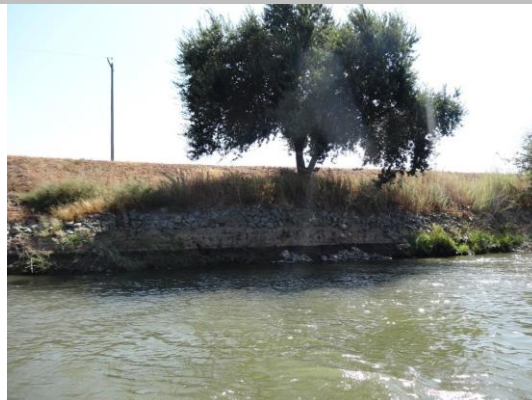
Photo 4 of 4 : FA_2018_RD2062_311_2_20180906_00008.jpg

Comment Code						
Inspector Comment						
09/13/2017: The erosion site has expanded significantly with the erosion length increased to approximately 90 ft from 40 ft. Signs of animal activities have been found at the site.						
07/25/2016: No significant change observed.						
06/25/2015: No significant change observed.						
07/02/2014: No significant change observed.						
08/13/2013: No significant change observed.						
08/07/2012: The site has been visited by boat survey. No significant change observed						
08/23/2011: Hard to view the erosion because of the dense vegetation and trees on site. The site is under the bush, close to the tree. [2017 Site ID:RD2062U03RM30.02]

Close view of the erosion.

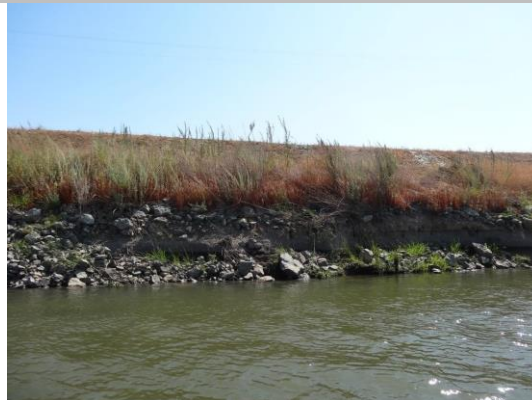
Photo 1 of 3 : FA_2018_RD2062_311_3_20180906_00009.jpg

LM Start	0.17	Rating **	M	Issue No.	3
LM End	0.17	Issue Type +	Ma	Location *	WS
Category	Supplemental			GPS Latitude/Longitude	
				Start	End
Item	DWR Erosion Survey			37.810268 °	37.810268 °
				-121.387495 °	-121.387495 °
DWR ID	DWR_RD2062_03_s_2018_3				
Comment Code					
Inspector Comment					
09/13/2017: No significant change observed.					
07/25/2016: No significant change observed.					
06/25/2015: No significant change observed.					
07/02/2014: No significant change observed.					
08/13/2013: No significant change observed.					
08/07/2012: The site has been visited by boat survey. No significant change observed					
08/23/2011: The protection at the levee toe has been washed away.					
[2017 Site ID:RD2062U03RM30.1]

Direct view of the site.

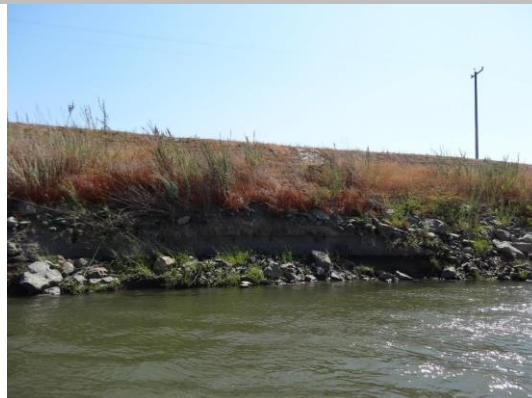
Photo 2 of 3 : FA_2018_RD2062_311_3_20180906_00010.jpg

LM Start	0.17	Rating **	M	Issue No.	3 (cont)	
LM End	0.17	Issue Type +	Ma	Location *	WS	
Category	Supplemental			GPS Latitude/Longitude		
				Start		End
Item	DWR Erosion Survey			37.810268 °		37.810268 °
				-121.387495 °		-121.387495 °
DWR ID	DWR_RD2062_03_s_2018_3					
Comment Code						
Inspector Comment						
09/13/2017: No significant change observed.						
07/25/2016: No significant change observed.						
06/25/2015: No significant change observed.						
07/02/2014: No significant change observed.						
08/13/2013: No significant change observed.						
08/07/2012: The site has been visited by boat survey. No significant change observed						
08/23/2011: The protection at the levee toe has been washed away.						
[2017 Site ID:RD2062U03RM30.1]

Close view of the erosion.

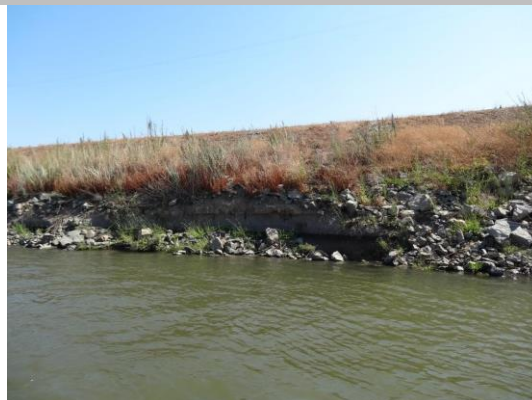
Photo 3 of 3 : FA_2018_RD2062_311_3_20180906_00011.jpg

Close view of the erosion.

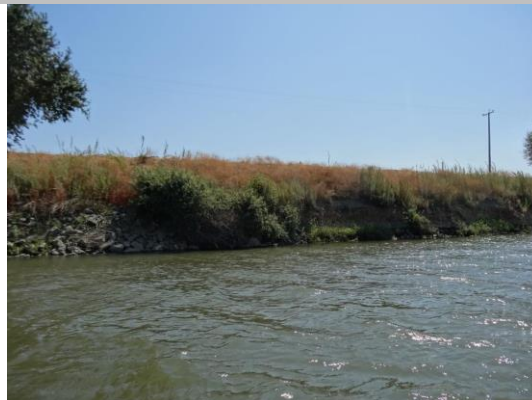
Photo 1 of 4 : FA_2018_RD2062_311_4_20180906_00012.jpg

Comment Code					
Inspector Comment					
09/13/2017: The erosion has developed vertically. More vegetaion at the site.					
07/25/2106: No significant change observed. More vegetation observed at the site.					
06/25/2015: No significant change observed.					
07/02/2014: No significant change observed.					
08/13/2013: A new pocket erosion at the upper levee slope has been found directly above a large tree. The erosion might have been caused by internal pipe leakage or surface runoff.					
08/07/2012: The site has been visited by boat survey. No significant change observed					
08/23/2011: No significant change observed on site. Dense vegetation is visible along the water line.					
09/07/2010: No significant change observed on site. Much of the upper slope was recently cleared of vegetation by spraying. 4- to 6-foot vertical scarp and pocket erosions are lined along a span of 475 feet. In some sections, the vertical scarp encroaches into the levee prism. There is a lack of berm along this reach, exposing the levee slope to high flow velocities during normal and flood events.

08/06/2010: Recommended as local maintenance issue, per CLRO.					
03/09/2010: As discussed with Michael Moncrief of MBK Engineers, the site will be 'addressed' later this year.					
09/29/2009: No major change observed since last visit; pocket erosion and a vertical scarp forming; this site was combined with Site RM30.13 and 30.02 with a combined total erosion length of 475 feet; recommended as annual assessment and monitoring of the site, per CLRO CES Evaluation 2008 Report; previously rated "M".					
11/05/2008: Top of vertical scarp has rip rap that appears to be sliding; rodent holes; existing toe rip rap. [2017 Site ID:RD2062U03RM30.19]

View of the pocket erosion.

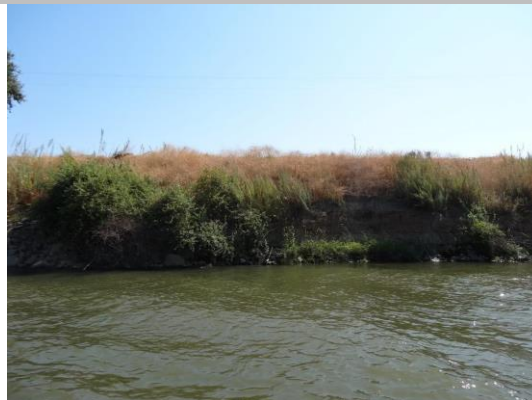
Photo 2 of 4 : FA_2018_RD2062_311_4_20180906_00013.jpg

Comment Code						
Inspector Comment						
09/13/2017: The erosion has developed vertically. More vegetaion at the site.						
07/25/2106: No significant change observed. More vegetation observed at the site.						
06/25/2015: No significant change observed.						
07/02/2014: No significant change observed.						
08/13/2013: A new pocket erosion at the upper levee slope has been found directly above a large tree. The erosion might have been caused by internal pipe leakage or surface runoff.						
08/07/2012: The site has been visited by boat survey. No significant change observed						
08/23/2011: No significant change observed on site. Dense vegetation is visible along the water line.						
09/07/2010: No significant change observed on site. Much of the upper slope was recently cleared of vegetation by spraying. 4- to 6-foot vertical scarp and pocket erosions are lined along a span of 475 feet. In some sections, the vertical scarp encroaches into the levee prism. There is a lack of berm along this reach, exposing the levee slope to high flow velocities during normal and flood events.

08/06/2010: Recommended as local maintenance issue, per CLRO.						
03/09/2010: As discussed with Michael Moncrief of MBK Engineers, the site will be 'addressed' later this year.						
09/29/2009: No major change observed since last visit; pocket erosion and a vertical scarp forming; this site was combined with Site RM30.13 and 30.02 with a combined total erosion length of 475 feet; recommended as annual assessment and monitoring of the site, per CLRO CES Evaluation 2008 Report; previously rated "M".						
11/05/2008: Top of vertical scarp has rip rap that appears to be sliding; rodent holes; existing toe rip rap. [2017 Site ID:RD2062U03RM30.19]

Close view of the pocket erosion. Note the dense vegetation at the site.

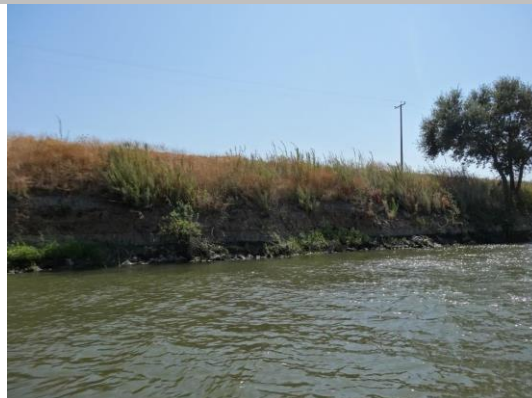
Photo 3 of 4 : FA_2018_RD2062_311_4_20180906_00014.jpg

Comment Code						
Inspector Comment						
09/13/2017: The erosion has developed vertically. More vegetaion at the site.						
07/25/2106: No significant change observed. More vegetation observed at the site.						
06/25/2015: No significant change observed.						
07/02/2014: No significant change observed.						
08/13/2013: A new pocket erosion at the upper levee slope has been found directly above a large tree. The erosion might have been caused by internal pipe leakage or surface runoff.						
08/07/2012: The site has been visited by boat survey. No significant change observed						
08/23/2011: No significant change observed on site. Dense vegetation is visible along the water line.						
09/07/2010: No significant change observed on site. Much of the upper slope was recently cleared of vegetation by spraying. 4- to 6-foot vertical scarp and pocket erosions are lined along a span of 475 feet. In some sections, the vertical scarp encroaches into the levee prism. There is a lack of berm along this reach, exposing the levee slope to high flow velocities during normal and flood events.

08/06/2010: Recommended as local maintenance issue, per CLRO.						
03/09/2010: As discussed with Michael Moncrief of MBK Engineers, the site will be 'addressed' later this year.						
09/29/2009: No major change observed since last visit; pocket erosion and a vertical scarp forming; this site was combined with Site RM30.13 and 30.02 with a combined total erosion length of 475 feet; recommended as annual assessment and monitoring of the site, per CLRO CES Evaluation 2008 Report; previously rated "M".						
11/05/2008: Top of vertical scarp has rip rap that appears to be sliding; rodent holes; existing toe rip rap. [2017 Site ID:RD2062U03RM30.19]

Front view of the site with dense vegetation.

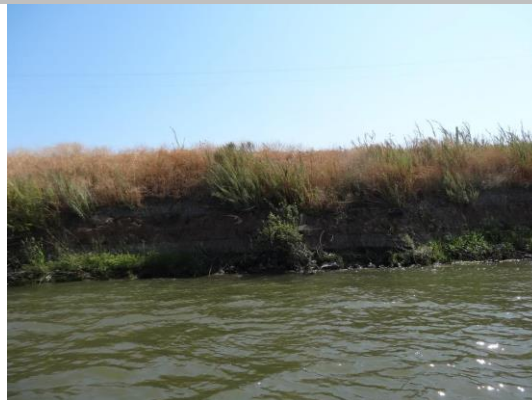
Photo 4 of 4 : FA_2018_RD2062_311_4_20180906_00015.jpg

Comment Code						
Inspector Comment						
09/13/2017: The erosion has developed vertically. More vegetaion at the site.						
07/25/2106: No significant change observed. More vegetation observed at the site.						
06/25/2015: No significant change observed.						
07/02/2014: No significant change observed.						
08/13/2013: A new pocket erosion at the upper levee slope has been found directly above a large tree. The erosion might have been caused by internal pipe leakage or surface runoff.						
08/07/2012: The site has been visited by boat survey. No significant change observed						
08/23/2011: No significant change observed on site. Dense vegetation is visible along the water line.						
09/07/2010: No significant change observed on site. Much of the upper slope was recently cleared of vegetation by spraying. 4- to 6-foot vertical scarp and pocket erosions are lined along a span of 475 feet. In some sections, the vertical scarp encroaches into the levee prism. There is a lack of berm along this reach, exposing the levee slope to high flow velocities during normal and flood events.

08/06/2010: Recommended as local maintenance issue, per CLRO.						
03/09/2010: As discussed with Michael Moncrief of MBK Engineers, the site will be 'addressed' later this year.						
09/29/2009: No major change observed since last visit; pocket erosion and a vertical scarp forming; this site was combined with Site RM30.13 and 30.02 with a combined total erosion length of 475 feet; recommended as annual assessment and monitoring of the site, per CLRO CES Evaluation 2008 Report; previously rated "M".						
11/05/2008: Top of vertical scarp has rip rap that appears to be sliding; rodent holes; existing toe rip rap. [2017 Site ID:RD2062U03RM30.19]

Front view of the site. The erosion has developed along the levee slope.

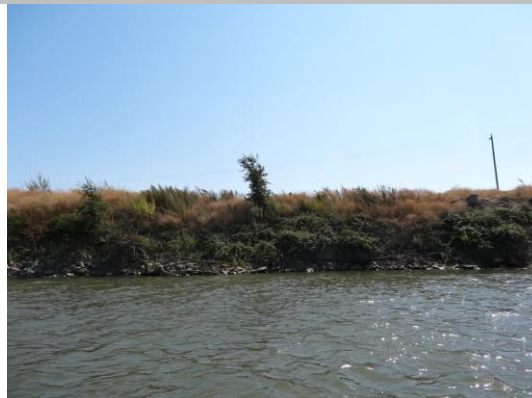
Photo 1 of 3 : FA_2018_RD2062_311_5_20180906_00016.jpg

Front view of the erosion.

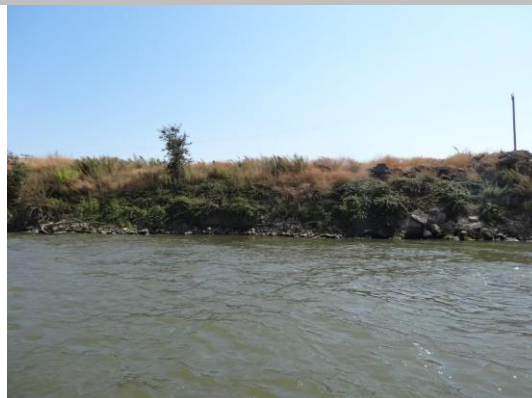
Photo 2 of 3 : FA_2018_RD2062_311_5_20180906_00017.jpg

Close view of the site. Note the dense vegetation at the site.

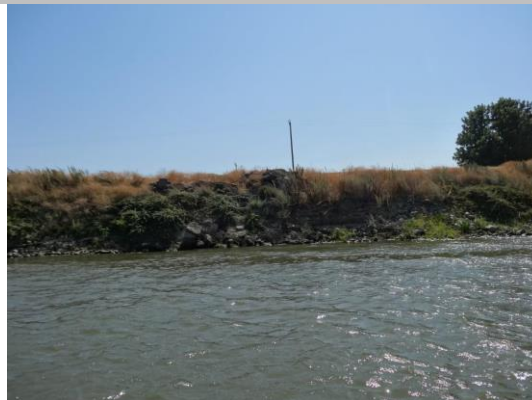
Photo 3 of 3 : FA_2018_RD2062_311_5_20180906_00018.jpg

LM Start	0.35	Rating **	M	Issue No.	5 (cont)	
LM End	0.35	Issue Type +	Ma	Location *	WS	
Category	Supplemental			GPS Latitude/Longitude		
				Start		End
Item	DWR Erosion Survey			37.811101°		37.811101°
				-121.384402°		-121.384402°
DWR ID	RD2062U03RM30.27					
Comment Code						
Inspector Comment						
09/13/2017: No significant change observed.						
07/25/2016: No significant change observed.						
06/25/2015: No significant change observed.						
07/02/2014: No significant change observed.						
08/13/2013: No significant change observed.						
08/07/2012: The site has been visited by boat survey. No significant change observed						
08/23/2011: The site is right at the downstream of a river bend. [2017 Site ID:RD2062U03RM30.27]

Front view of the erosion.

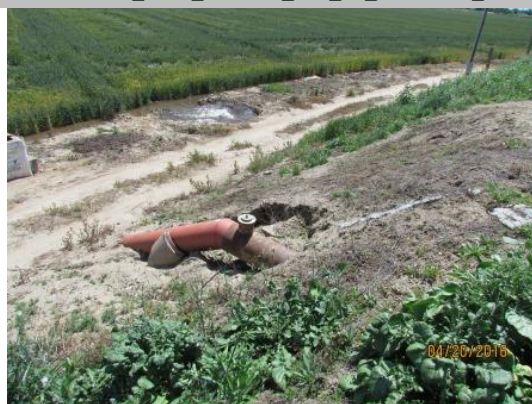
Photo 1 of 1 : FA_2018_RD2062_311_38_20180906_00039.jpg

LM Start	0.51	Rating **	M	Issue No.	38
LM End	0.51	Issue Type +	Ma	Location *	LS
Category	Earthen Levee			GPS Latitude/Longitude	
				Start	End
Item	Erosion / Bank Caving			37.812552°	37.812552°
				-121.382781°	-121.382781°
DWR ID	DWR_RD2062_03_s_2016_38				
Comment Code					
E2 : Schedule repair of erosion site prior to the next inspection.					
Inspector Comment

View of the landside levee slope erosion around the pipe.

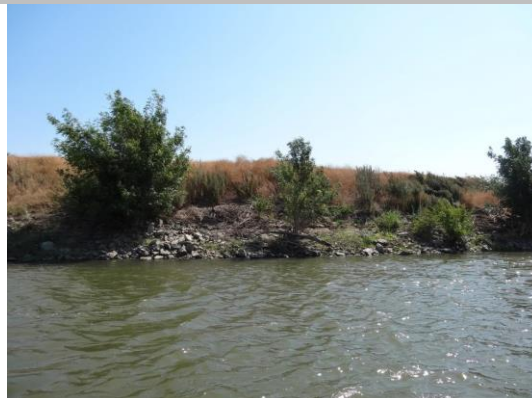
Photo 1 of 3 : FA_2018_RD2062_311_7_20180906_00019.jpg

09/13/2017: No significant change observed.
 07/25/2016: No significant change observed.
 06/25/2015: No significant change observed.
 07/02/2014: No significant change observed.
 08/13/2013: No significant change observed.
 08/07/2012: The site has been visited by boat survey. No significant change observed.
 08/23/2011: No significant change observed on site.
 09/07/2010: No significant change observed on site. Much of the placed rip rap revetment has slid. It is no longer adequately protecting the slope.
 08/06/2010: Recommended as local maintenance issue, per CLRO Report.
 03/09/2010: As discussed with Michael Moncrief of MBK, site will be 'addressed' this year.
 09/29/2009: No major change observed since last visit; a section of the rip rap has slipped, exposing a levee section that has eroded; recommended as local maintenance issue, per CLRO CES Evaluation 2008 Report; Site # is the same as RM30.43, LM0.63; previously rated "U".

Close view of the site.

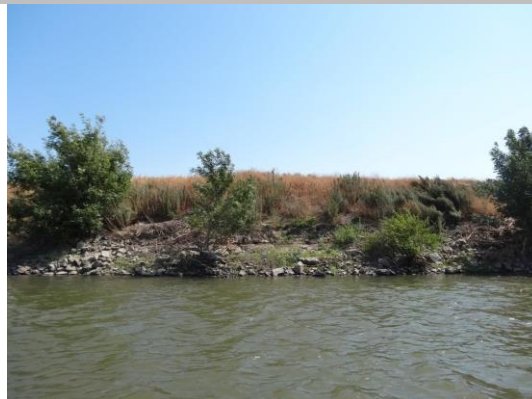
Photo 2 of 3 : FA_2018_RD2062_311_7_20180906_00020.jpg

Front view of the site.

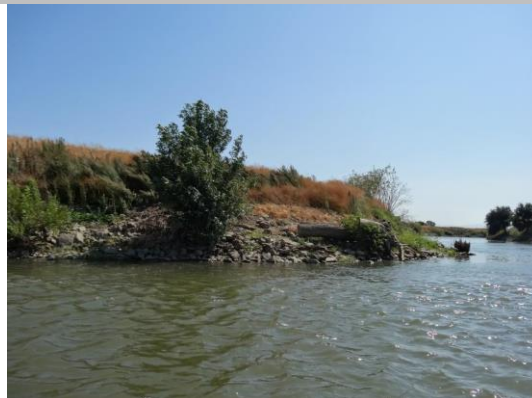
Photo 3 of 3 : FA_2018_RD2062_311_7_20180906_00021.jpg

Comment Code						
Inspector Comment						
09/13/2017: No significant change observed.						
07/25/2016: No significant change observed.						
06/25/2015: No significant change observed.						
07/02/2014: No significant change observed.						
08/13/2013: No significant change observed.						
08/07/2012: The site has been visited by boat survey. No significant change observed.						
08/23/2011: No significant change observed on site.						
09/07/2010: No significant change observed on site. Much of the placed rip rap revetment has slid. It is no longer adequately protecting the slope.						
08/06/2010: Recommended as local maintenance issue, per CLRO Report.						
03/09/2010: As discussed with Michael Moncrief of MBK, site will be 'addressed' this year.						
09/29/2009: No major change observed since last visit; a section of the rip rap has slipped, exposing a levee section that has eroded; recommended as local maintenance issue, per CLRO CES Evaluation 2008 Report; Site # is the same as RM30.43,LM0.63; previously rated "U".

Front view of the site.

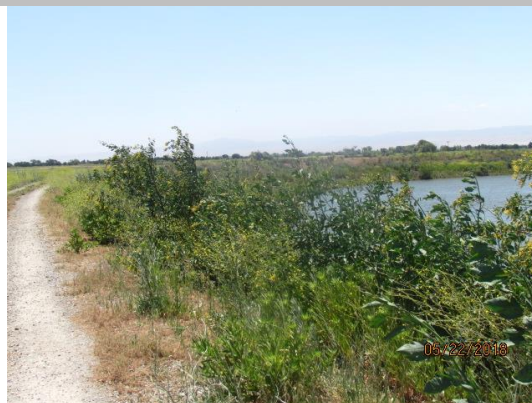
Photo 1 of 3 : FA_2018_RD2062_311_22_20180906_00035.jpg

LM Start	0.74	Rating **	U	Issue No.	22
LM End	1.36	Issue Type +	Ma	Location *	WS
Category	Earthen Levee			GPS Latitude/Longitude	
				Start	End
Item	Vegetation			37.815262 °	37.821072 °
				-121.381455 °	-121.377031 °
DWR ID	DWR_RD2062_03_s_2018_22				
Comment Code					
V2 : Remove the wild growth other than native grasses from the levee slopes.					
Inspector Comment

Looking southwest at dense vegetation (Tobacco plants) on waterward slope. (Spring 2018)

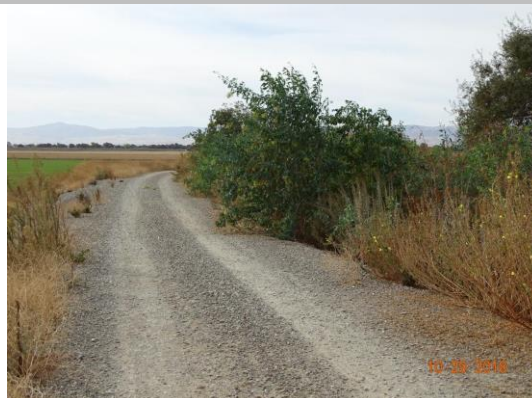
Photo 2 of 3 : FA_2018_RD2062_311_22_20181101_00055.jpg

Looking west at dense veg. on waterward slope. (Fall 2018)

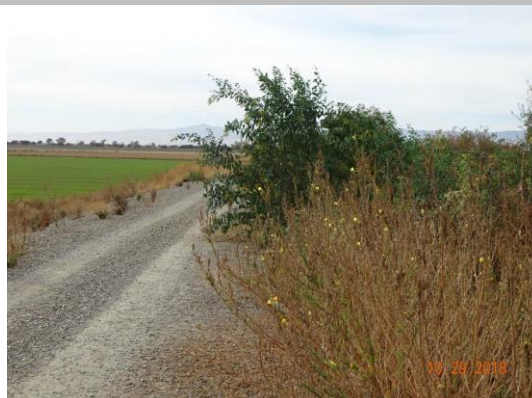
Photo 3 of 3 : FA_2018_RD2062_311_22_20181101_00056.jpg

Looking southwest at dense veg (Tabacco plant) on waterward slope. (Fall 2018)

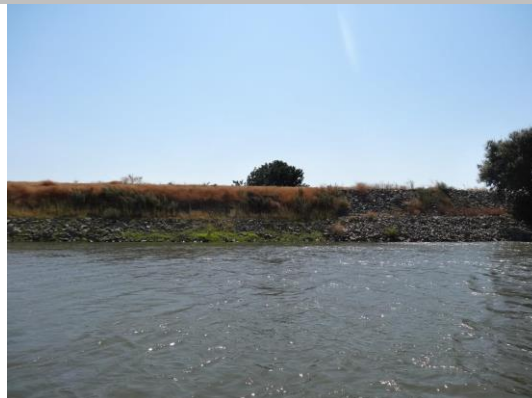
Photo 1 of 3 : FA_2018_RD2062_311_8_20180906_00022.jpg

Comment Code					
Inspector Comment					
09/13/2017: No significant change observed.					
07/25/2016: No significant change observed.					
06/25/2015: No significant change observed.					
07/02/2014: No significant change observed.					
08/13/2013: No significant change observed.					
08/07/2012: The site has been visited by boat survey. No significant change observed					
08/23/2011: No significant change observed on site.					
09/07/2010: No significant change observed on site. Much of the seasonal grass along the slope was cleared. Site consists of an existing scalloped erosion approximately 30 feet long by 5 feet wide at its widest opening. The lateral crack is extended outwards along the middle slope. There is a 1 to 2 feet of differential settlement that could further develop into a shallow slide.					
08/06/2010: Recommended as local maintenance issue, per CLRO.					
03/09/2010: As discussed with Michael Moncrief of MBK Engineer, site will be 'addressed' this year.

09/28/2009: No major change observed; section of rip rap has slipped, creating a terraced effect; dense vegetation growth; recommended as a local maintenance issue, per CLRO CES Evaluation 2008 Report; Site # is the same as RM31.12,LM1.25; previously rated "U".					
09/14/2006: 1-2' into prism. [2017 Site ID:RD2062U03RM31.12]

Front view of the site.

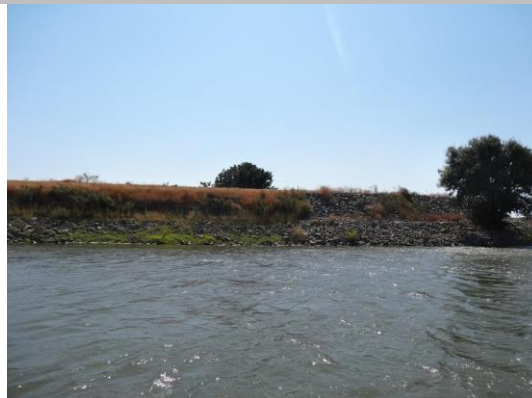
Photo 2 of 3 : FA_2018_RD2062_311_8_20180906_00023.jpg

Front view of the site.

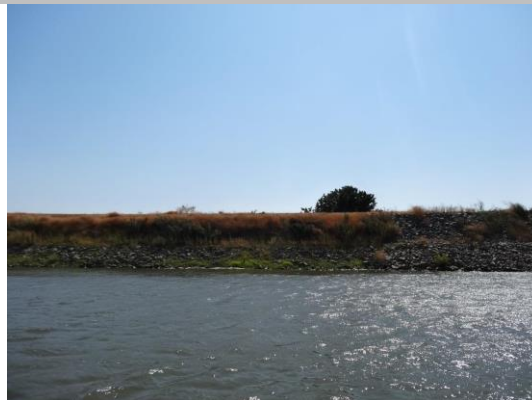
Photo 3 of 3 : FA_2018_RD2062_311_8_20180906_00024.jpg

Comment Code						
Inspector Comment						
09/13/2017: No significant change observed.						
07/25/2016: No significant change observed.						
06/25/2015: No significant change observed.						
07/02/2014: No significant change observed.						
08/13/2013: No significant change observed.						
08/07/2012: The site has been visited by boat survey. No significant change observed						
08/23/2011: No significant change observed on site.						
09/07/2010: No significant change observed on site. Much of the seasonal grass along the slope was cleared. Site consists of an existing scalloped erosion approximately 30 feet long by 5 feet wide at its widest opening. The lateral crack is extended outwards along the middle slope. There is a 1 to 2 feet of differential settlement that could further develop into a shallow slide.						
08/06/2010: Recommended as local maintenance issue, per CLRO.						
03/09/2010: As discussed with Michael Moncrief of MBK Engineer, site will be 'addressed' this year.

09/28/2009: No major change observed; section of rip rap has slipped, creating a terraced effect; dense vegetation growth; recommended as a local maintenance issue, per CLRO CES Evaluation 2008 Report; Site # is the same as RM31.12,LM1.25; previously rated "U".						
09/14/2006: 1-2' into prism. [2017 Site ID:RD2062U03RM31.12]

Front view of the site.

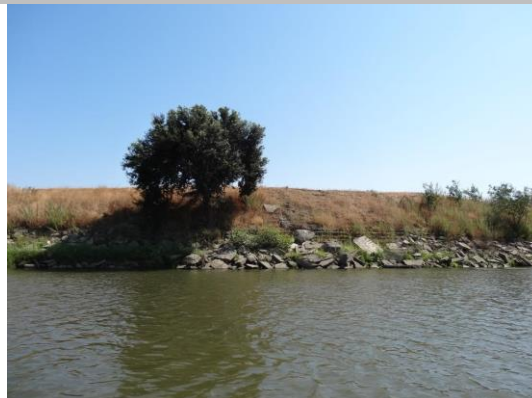
Photo 1 of 4 : FA_2018_RD2062_311_9_20180906_00025.jpg

Comment Code					
Inspector Comment					
09/13/2017: No significant change observed. 07/25/2016: No significant change observed. 06/25/2015: No significant change observed. 07/02/2014: No significant change observed. 08/13/2013: No significant change observed. 08/07/2012: The site has been visited by boat survey. No significant change observed 08/23/2011: No significant change observed on site. 09/07/2010: No significant change observed on site. There is a small- to medium sized Oak tree on the mid-slope just above rip rap. Some of the rip rap has collapsed, creating a pocket erosion just above the existing toe rip rap and upstream of the Oak tree. 08/06/2010: Recommended as local maintenance issue, per CLRO. 03/09/2010: As discussed with Michael Moncrief of MBK Engineer, site will be 'addressed' in 2010. 09/29/2009: No major change since last visit; sliding of the rip rap at the base of the lone tree; there is noticeable man-made trail and foot traffic extending from the crown to the toe; much of the broken concrete used as temporary rip rap has slid, exposing portion of the bare levee slope; recommended as local maintenance issue, per CLRO CES Evaluation 2008 Report; Site # is the same as RM31.3, LM1.45; previously rated "M". 11/05/2008: Portion of rip rap collapsing. 09/14/2006: Portion of rip rap along the slope has collapsed; exposed levee section is starting to erode, exposing roots from the nearby tree. [2017 Site ID:RD2062U03RM31.28]

Front view of the erosion site.

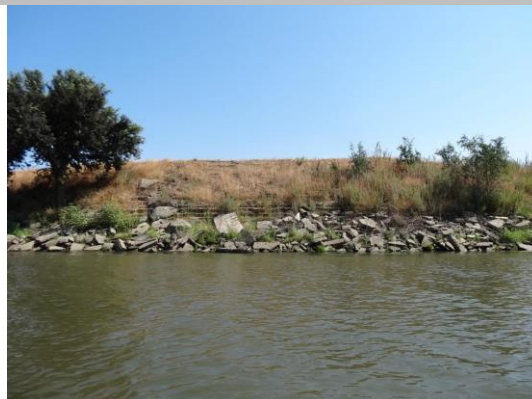
Photo 2 of 4 : FA_2018_RD2062_311_9_20180906_00026.jpg

Close view of the site.

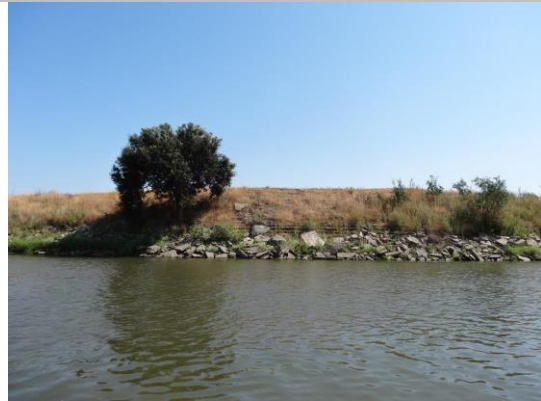
Photo 3 of 4 : FA_2018_RD2062_311_9_20180906_00027.jpg

Comment Code						
Inspector Comment						
09/13/2017: No significant change observed.						
07/25/2016: No significant change observed.						
06/25/2015: No significant change observed.						
07/02/2014: No significant change observed.						
08/13/2013: No significant change observed.						
08/07/2012: The site has been visited by boat survey. No significant change observed						
08/23/2011: No significant change observed on site.						
09/07/2010: No significant change observed on site. There is a small- to medium sized Oak tree on the mid-slope just above rip rap. Some of the rip rap has collapsed, creating a pocket erosion just above the existing toe rip rap and upstream of the Oak tree.						
08/06/2010: Recommended as local maintenance issue, per CLRO.						
03/09/2010: As discussed with Michael Moncrief of MBK Engineer, site will be 'addressed' in 2010.						
09/29/2009: No major change since last visit; sliding of the rip rap at the base of the lone tree; there is noticeable man-made trail and foot traffic extending from the crown to the toe; much of the broken concrete used as temporary rip rap has slid, exposing portion of the bare levee slope; recommended as local maintenance issue, per CLRO CES Evaluation 2008 Report; Site # is the same as RM31.3, LM1.45; previously rated "M".

Front view of the site. Note the existing broken concrete on levee slope and at the levee toe.

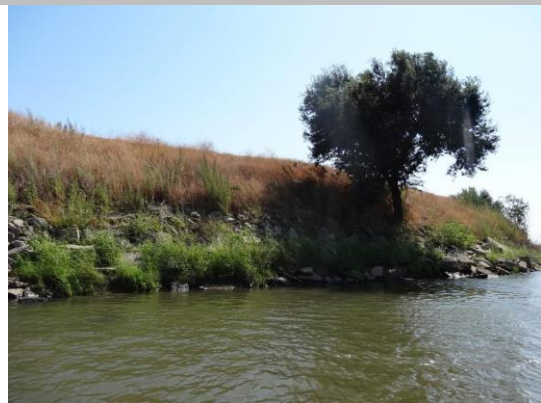
Photo 4 of 4 : FA_2018_RD2062_311_9_20180906_00028.jpg

Close view of the site.

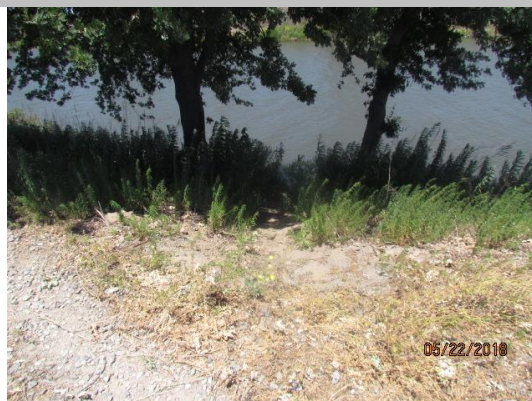
Photo 1 of 1 : FA_2018_RD2062_311_20_20180906_00034.jpg

LM Start	2.18	Rating **	M	Issue No.	20
LM End	2.18	Issue Type +	Ma	Location *	WS
Category	Earthen Levee			GPS Latitude/Longitude	
				Start	End
Item	Slope Stability			37.818725 °	37.818725 °
				-121.363762 °	-121.363762 °
DWR ID	DWR_RD2062_03_s_2018_20				
Comment Code					
S2 : Repair the levee slope damaged by foot traffic and prevent access where possible.					
Inspector Comment					
Slope damage caused by foot traffic on waterward slope.

Looking west at slope damage (foot traffic) on waterward slope. (Spring 2018)

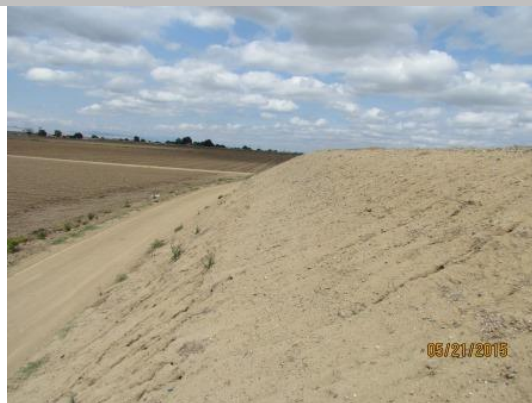
Photo 1 of 1 : FA_2018_RD2062_311_31_20180906_00036.jpg

LM Start	3.61	Rating **	M	Issue No.	31
LM End	3.66	Issue Type +	Ma	Location *	LS
Category	Earthen Levee			GPS Latitude/Longitude	
				Start	End
Item	Erosion / Bank Caving			37.816982 °	37.816541 °
				-121.342939 °	-121.342191 °
DWR ID	DWR_RD2062_03_s_2015_31				
Comment Code					
E2 : Schedule repair of erosion site prior to the next inspection.					
Inspector Comment					
About a 3 ft vertical cut at the levee toe into the levee prism.

View of the eroded landside levee toe.

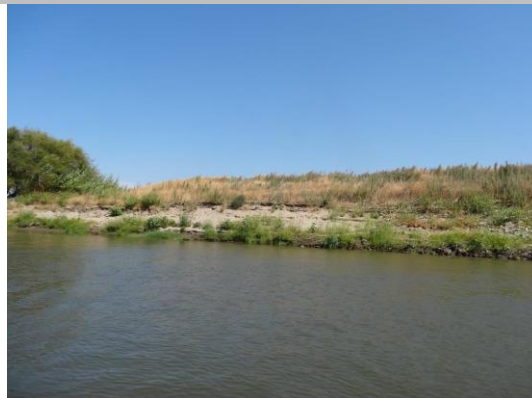
Photo 1 of 3 : FA_2018_RD2062_311_10_20180906_00029.jpg

Front view of the erosion located at the inside of a sharp river bend.

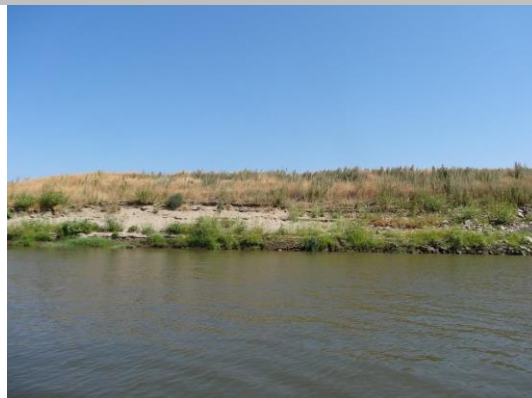
Photo 2 of 3 : FA_2018_RD2062_311_10_20180906_00030.jpg

Close view of the erosion.

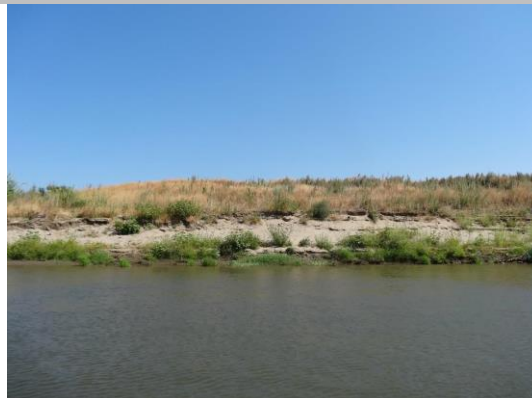
Photo 3 of 3 : FA_2018_RD2062_311_10_20180906_00031.jpg

Close view of the erosion. Note the sandy material of the river bank at the erosion site.

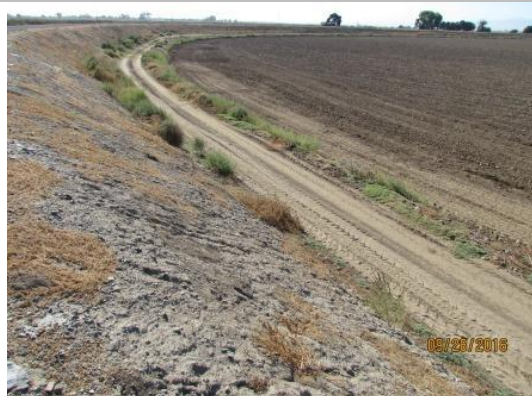
Photo 1 of 1 : FA_2018_RD2062_311_37_20180906_00038.jpg

LM Start	4.30	Rating **	M	Issue No.	37
LM End	4.35	Issue Type +	Ma	Location *	LS
Category	Earthen Levee			GPS Latitude/Longitude	
				Start	End
Item	Erosion / Bank Caving			37.819436 °	37.819096 °
				-121.335469 °	-121.334829 °
DWR ID	DWR_RD2062_03_f_2016_37				
Comment Code					
E2 : Schedule repair of erosion site prior to the next inspection.					
Inspector Comment					
Toe road encroaches into the levee toe.

View of the toe road encroaching into the levee prism.

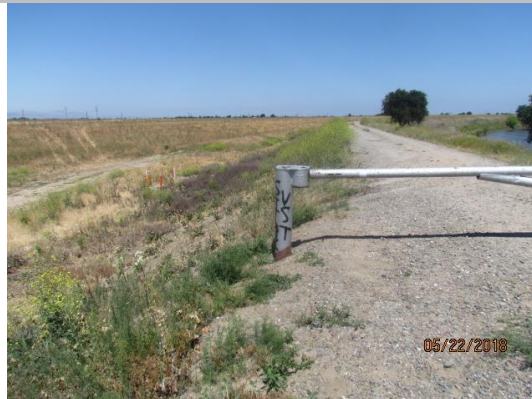
Photo 1 of 1 : FA_2018_RD2062_311_17_20180906_00032.jpg

Looking north at gate (lock mechanism) should be replace or fixed.
(Spring 2018)

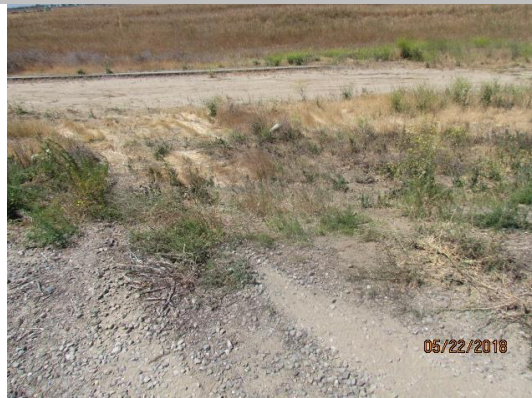
Photo 1 of 1 : FA_2018_RD2062_311_19_20180906_00033.jpg

Looking west slope damage due to vehicle traffic. (Spring 2018)
